1993 SOUTHEASTERN MT MAINTENANCE PROJECT

DSL - AMRB No. 93-M04

FINAL REPORT

SPECTRUM ENGINEERING

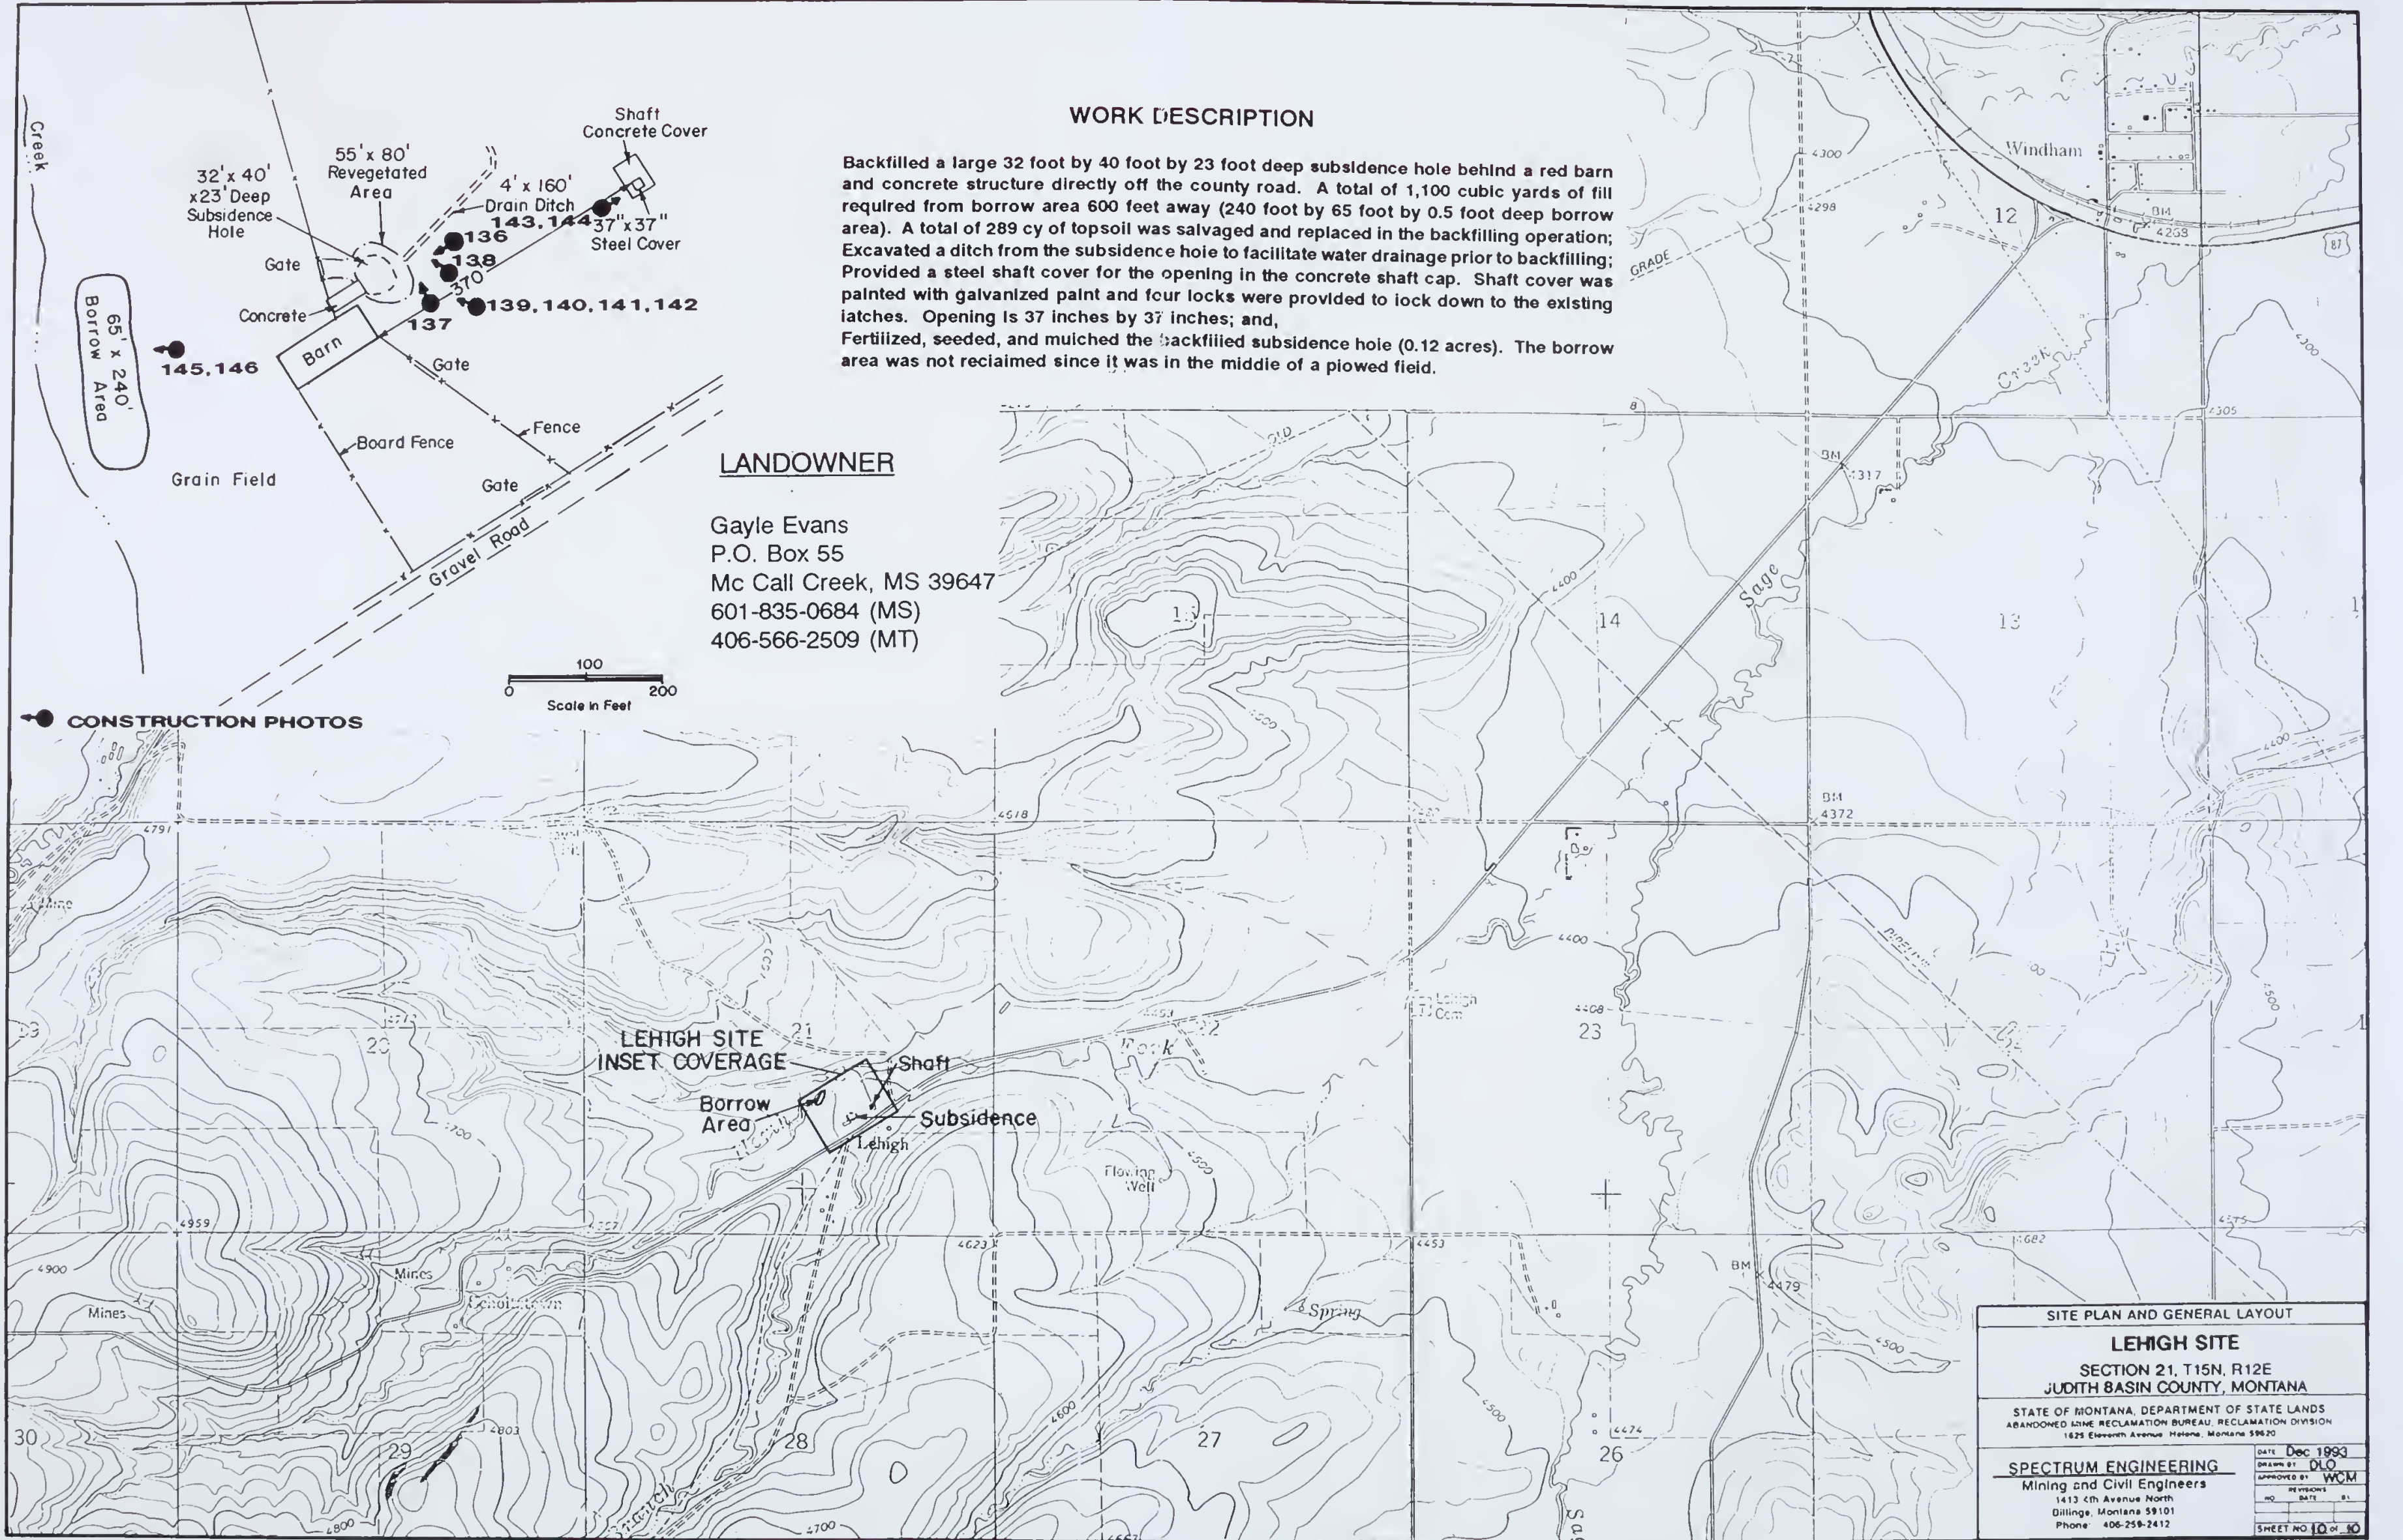
AS-BUILT DRAWING AND PHOTO INDEX

Backfilled a large 32 foot by 40 foot by 23 foot deep subsidence hole behind a red barn and concrete structure directly off the county road. A total of 1,100 cubic yards of fill required from borrow area 600 feet away (240 foot by 65 foot by 0.5 foot deep borrow area). A total of 289 cy of topsoil was salvaged and replaced in the backfilling operation; Excavated a ditch from the subsidence hole to facilitate water drainage prior to backfilling; Provided a steel shaft cover for the opening in the concrete shaft cap. Shaft cover was painted with galvanized paint and four locks were provided to lock down to the existing latches. Opening is 37 inches by 37 inches; and, Fertilized, seeded, and mulched the backfilled subsidence hole (0.12 acres). The borrow area was not reclaimed since it was in the middle of a plowed field.
